ELECTROCHEMICAL IMPEDANCE SPECTROSCOPY EVALUATION OF PRIMED BMI-GRAPHITE/ALUMINUM GALVANIC SYSTEM

Rimi O. Rivera and Narinder K. Mehta
Naval Air Warfare Center, Aircraft Division, Patuxent River, MD

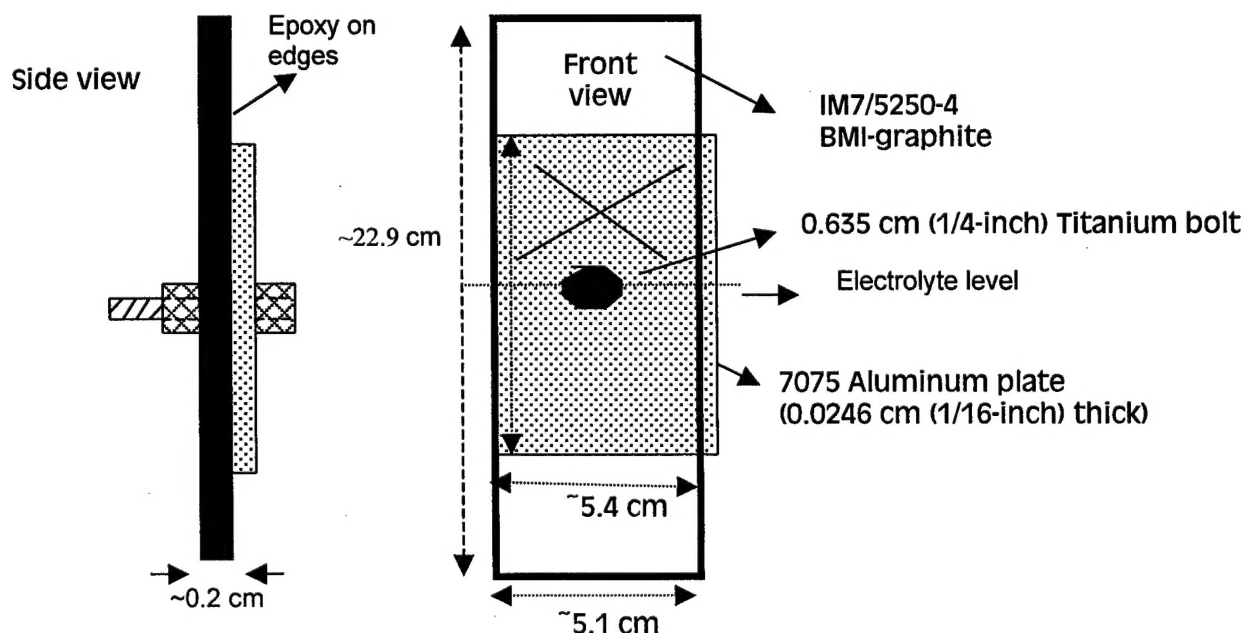
Figure 1. BMI-graphite/aluminum assembly configuration with "X" grooved on aluminum surface above titanium bolt.

The focus of the experiment was to simulate the galvanic couple created in BMI-graphite/aluminum joints under "real world" aircraft environmental exposure conditions. Specimens were prepared using Hexcel Corporation's 5250-4/IM7 BMI-graphite material attached to a 7075-T6 aluminum plate using a titanium (Ti) bolt. Sixteen plies, in a unidirectional configuration, were used to fabricate the BMI-graphite plate. Both sides of BMI-graphite composite (~22.9 cm x ~5.1 cm) and the aluminum (~10.2 cm x 5.4 cm) plates were primed with MIL-P-23377 epoxy primer and allowed to cure at room temperature for two weeks before assembly with a titanium bolt into the test configuration shown in Figure 1. In one of the test configurations, a 2-mil (0.002-inch) groove, shaped like an "X", was milled thru the primer to expose the bare metal on the upper half of the front face of the aluminum plate to accelerate the onset of galvanic couple. Un-primed bolted configurations were also prepared to obtain baseline EIS data at room temperature.

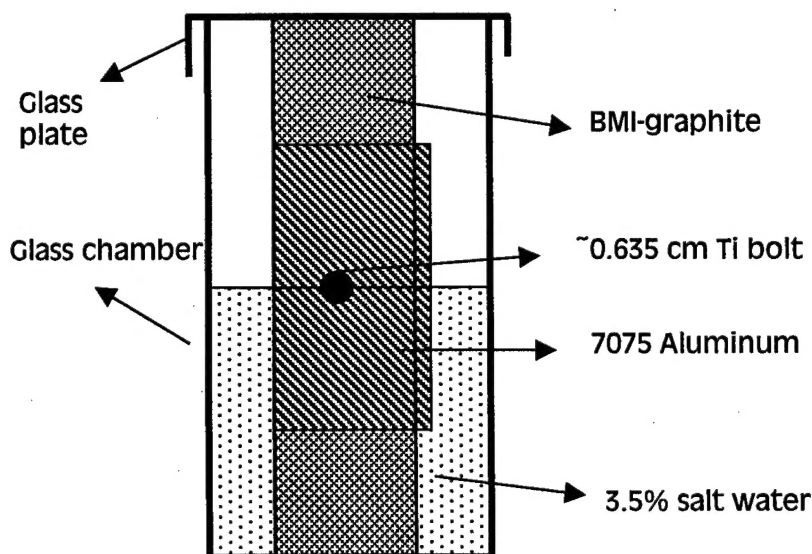
Figure 2. Test set up for BMI-graphite/aluminum assembly

Test specimens were immersed vertically in a rectangular 4-liter PyrexTM glass chamber containing 3.5% salt-water solution. Testing was conducted in a laboratory oven maintained at 180°F. The top of the chamber had an airtight removable glass plate for the removal and insertion of test assemblies. The water level was maintained at the center of the Ti bolt. In other words, half of the specimen was submerged in the salt-water electrolytic solution while the

other half was exposed to the moisture-saturated air environment. Figure 2 shows a diagram of the exposure setup configuration.

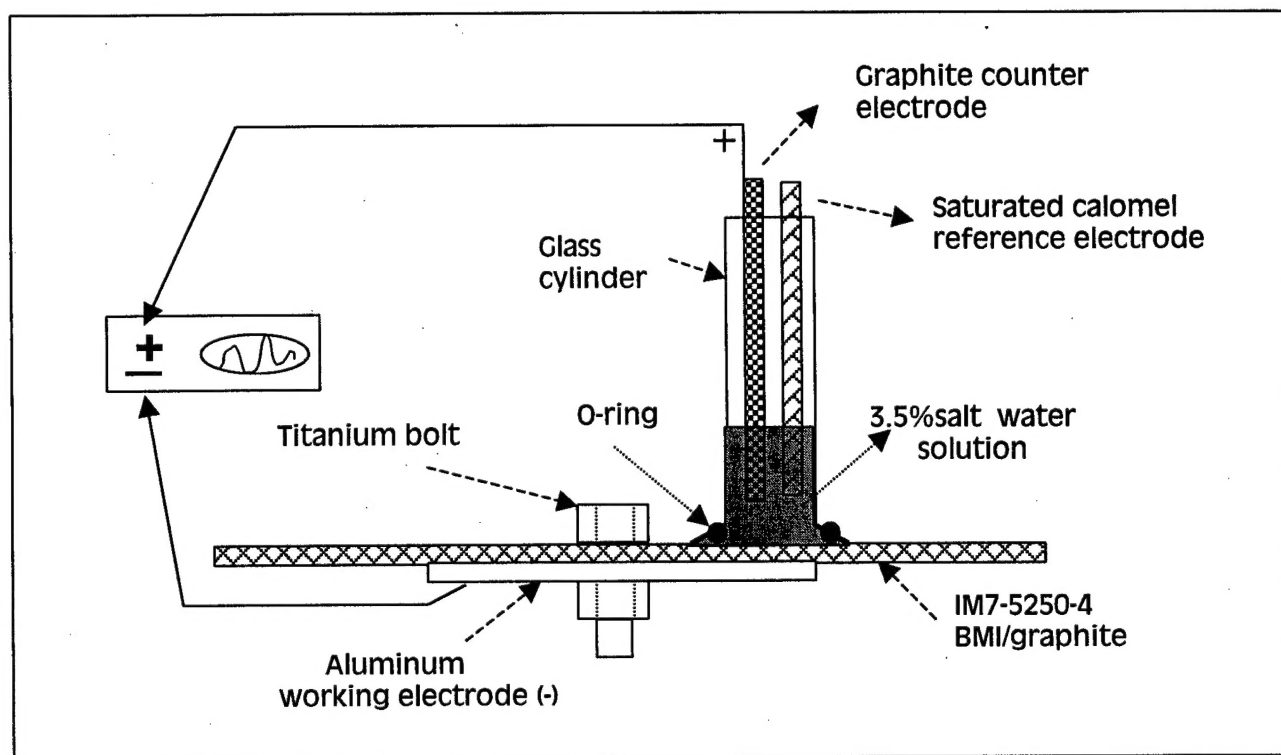
Figure 3. EIS test cell configuration

For an optimum EIS test run, specimens were taken out of the salt solution and wiped with paper tissue to remove excess electrolyte solution remaining on the surface. Specimens were maintained in a vertical position to avoid seeping of residual electrolyte embedded between the composite material and the aluminum plate on the section of the specimen immersed in the solution into the portion of the assembly that was not immersed. The EIS test cell consisted of a glass cylinder clamped with an O-ring seal on the composite surface, slightly tilted to avoid seeping of electrolyte. The cell was clamped approximately one centimeter away from the titanium bolt on the composite surface not immersed in the electrolytic solution. The cell area was 7.544 squared centimeters (cm^2). Approximately 30-35 milliliters of 3.5% salt-water solution was added to the test cell for making the impedance measurements. The graphite rod counter electrode and the saturated calomel reference electrode were adjusted to reach about 1 millimeter above the BMI-graphite surface for all the EIS measurements. Figure 3 shows a schematic of the EIS test cell configuration.

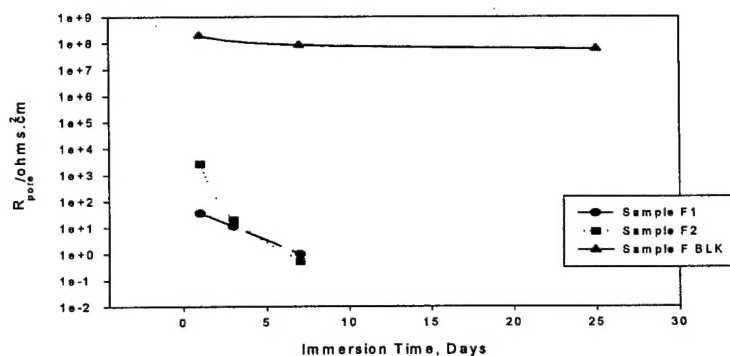
Figure 5. Pore Resistance for un-primed BMI-graphite composite/Al assemblies exposed to 3.5% salt solution at 180°F. No "X" grooved on any surface (undamaged)

The degradation trend of the exposed test assemblies F1 and F2 followed a similar pattern as reported in previous work^{3,8} done with similar specimens at room and elevated temperatures. R_{ct} for F1 and F2 decreased drastically within 24 hours of exposure; it was in the range of 10^5 ohms-cm² as compared to 10^{10} ohms-cm² for the control specimen in air at room temperature (data not shown). The samples degraded completely at a very fast rate within 7-days of exposure time. It was not possible to record EIS spectra for these samples after 7-days of exposure time due to the severity of degradation. Also, Q_{dl} increased drastically within 1-day of exposure reflecting extreme damage to the composite. The data reflected the occurrence of extensive surface adsorption of water/ion species by the polymeric BMI-graphite composite material within 7 days of exposure time. As shown in Figure 5, R_{pore} also decreased drastically within 1-day of exposure time. It reached ~ 1 ohms-cm² for 7-day exposure time as compared to 10^8 ohms-cm² for the control sample for the same test period. A drastic decrease in R_{pore} reflects the

development of porosity and absorption of water and other chemical species diffusing along the fiber-matrix interface at a very fast rate to increase the electrochemical sites.

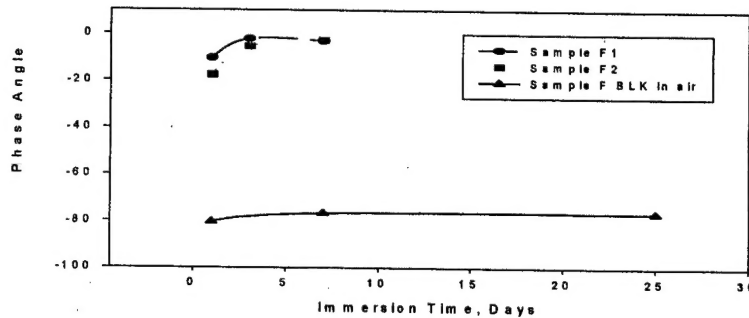
Figure 6. High frequency phase angle for un-primed BMI-graphite composite/Al assemblies exposed to 3.5% salt solution at 180°F. No "X" grooved on any surface (undamaged)

As shown in Figure 6, the shift in Bode phase angle in the high frequency (i.e., 10^4 Hz) range as a function of immersion time was also drastic for the duplicate test assemblies as compared to the control specimen. It reached a value of $< -20^\circ$ within 1-day of exposure and reached almost zero degree within 7-day of exposure whereas the control sample demonstrated a highly capacitive behavior with $\sim -80^\circ$ phase angle value in high frequency range. The impedance Bode plots for F1 and F2 assemblies demonstrated a drastic reduction in its slopes within 7-day of immersion time reflecting diffusion and onset of Warburg impedance. The plots also reflect fast kinetics resulting in rapid growth of pores and cavities due to diffusion of electrolyte and other chemical species into the BMI-graphite matrix, and are probably responsible for initiation of side reactions to accelerate the degradation of BMI resin in the composite material. The data has reflected that galvanic couple started developing within hours of exposure of test specimens to 3.5% NaCl at 180°F. As expected, at the end of the 7-day test period, aluminum plates in the test assemblies were found to be oxidized (or degraded) with white metal hydroxide and chloride gelatin precipitates all around the metal edges and in the solution.

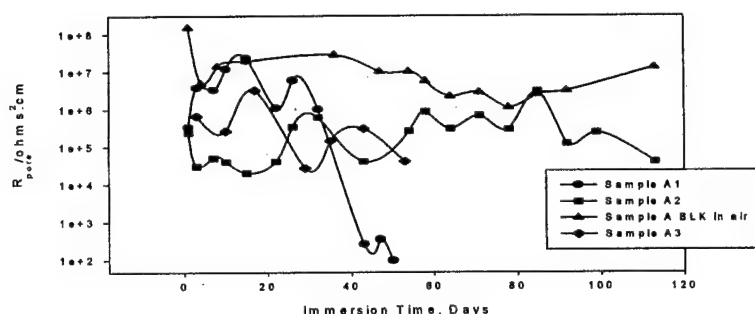
Figure 7. Pore Resistance for primed BMI-graphite composite/Al assemblies exposed to 3.5% salt solution. No "X" grooved on any surface (undamaged)

R_{ct} for A1 specimen was in the range 10^8 - 10^9 ohms-cm² for up to 32 days of immersion time and decreased drastically to 4×10^3 ohms-cm² between 32-43 days of exposure with a simultaneous increase in Q_{dl} from its approximate value of 10^{-8} - 10^{-9} Farad-cm⁻² for up to 32 days of immersion time to 5×10^{-4} Farad-cm⁻² between 32-43 days of exposure (data not shown). It reflected onset of corrosion between the metal and composite interface due to diffusion of electrolyte, water and other species. It also reflected that the primer resistance decreased due to diffusion of electrolyte into the interface between the primer and the composite. This diffusion is responsible for the initiation and development of conductive paths for early formation of cavities and delamination of the primer. As shown in Figure 7, R_{pore} for A1 assembly also decreased drastically for between 32-43 days of exposure time reflecting development of porosity and gradual absorption of water, electrolyte and other chemical species diffusing along the primer-fiber-matrix interface to increase the electrochemical areas. Once the integrity of the primer is compromised due to delamination or development of cracks/crevices in the primer film, it is probable that crevices/blisters on the BMI-graphite composite at microscopic level started growing due to highly electrochemical diffusion activity created by mass and charge transfer. Pore resistance is due to ion conducting paths (fissures) that develop or start growing. The fissures and crevices may act as anodic sites and may help in the degradation of BMI matrix by developing galvanic couple with graphite in the composite.

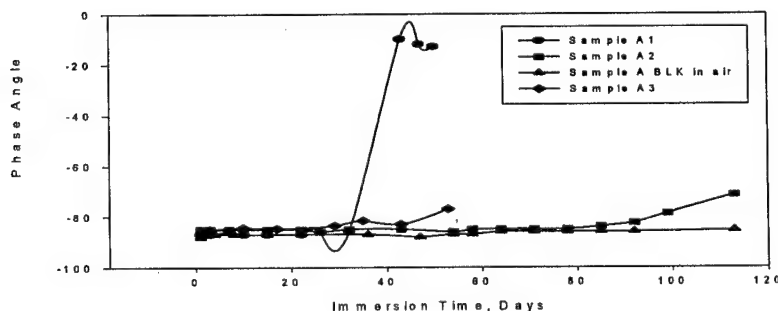
Figure 8. High frequency phase angle for primed BMI-graphite/Al assemblies exposed to 3.5% salt solution at 180°F . No "X" grooved on any surface (undamaged)

Bode phase angle (Figure 8) in the high frequency range ($\sim 10^4$ Hz) demonstrated a drastic decrease in its value from -86° to -10° between 32-46 days of exposure time reflecting that pores and cavities started growing due to diffusion of electrochemical species and water into the primer-composite interface, and that it has initiated side reactions to accelerate the degradation of BMI resin in A1 assembly.

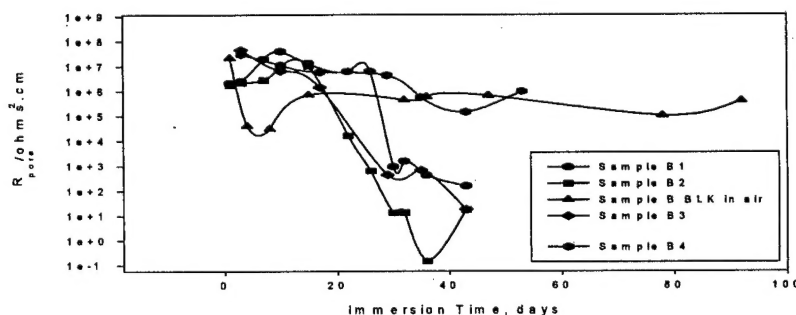
Figure 9. Pore resistance for primed BMI-graphite composite/Al assemblies exposed to 3.5% salt solution at 180°F. "X" grooved on Al surface above Ti Bolt.

The purpose of scratching/damaging the aluminum surface by marking a groove "X" was to accelerate the degradation of the primed composite-graphite matrix in a short time as in "real field" environmental conditions. R_{ct} for B1, B2 and B3 specimens were in the range 10^8 - 10^9 ohms- cm^2 for ~15-32 days of immersion time (data not shown). It decreased after this period with a simultaneous increase in Q_{dl} value from its approximate initial value of 10^{-9} Farad- cm^{-2} to 10^{-4} Farad- cm^{-2} for the same immersion time. It reflected that the primer film degraded quickly and permitted the diffusion of electrolyte and other species to develop conductive paths for the formation of cavities and fissures on the BMI-graphite composite surface. As shown in Figure 9, R_{pore} followed a similar pattern as of R_{ct} reflecting gradual absorption of water along the primer-fiber-matrix interface to accelerate the development of electrochemical sites for the onset of galvanic couple.

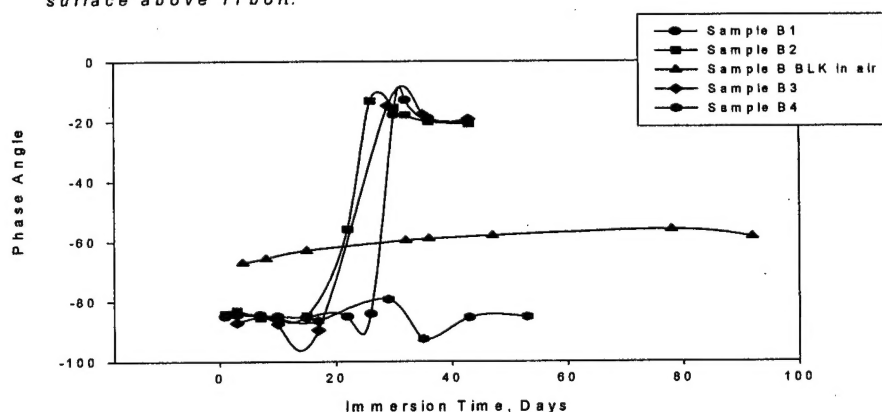
Figure 10. High frequency phase angle for primed BMI-graphite/Al assemblies exposed to 3.5% salt solution at 180°F. "X" grooved on Al surface above Ti bolt.

Figure 10 demonstrates the shift in the Bode phase angle in high frequency range for the specimens exposed to the salt solution at elevated temperature. As the surface porosity is increased due to the development of the electrochemical sites such as pores, crevices and fissures, the phase angle in the high frequency range starts decreasing due to gradual deterioration of primer and the composite matrix. Once, the pores and cavities starts growing, it augments the reduction of oxygen in the presence of exposed graphite fibers to produce hydroxyl ions, and thus initiates the BMI-matrix degradation kinetics. It is good to mention that for a pure capacitive impedance (primer/composite not damaged), the phase angle should be $\sim 90^\circ$. However, if diffusion of electrolyte, water and other ionic species is taking place the phase angle will decrease reflecting porous coating/material and poor adhesion (Warburg impedance). The fact that phase angle and its magnitude are decreasing gradually reflects moisture penetration down the fiber/matrix interface. A close visual look at the exposed B1, B2 and B3 assemblies reflected primer flakes delaminating from the composite surface and the degradation of the BMI resin was visible with the naked eye as shown in Photograph C. Assembly B4 did not demonstrate any onset of degradation for up to 53 days of exposure time. It reflects that the

primer is providing excellent inhibiting effect to electrical induction as well as to the development of microscopic cavities/pores on the primer-composite surface to enhance the onset of galvanic couple and also to the diffusion of electrolyte under the primer-composite-metal interphases.
